RIO GRANDE NATURAL AREA RIVER CONDITION ASSESSMENT APRIL 2016 REPORT

The report was prepared by Riverbend Engineering, LLC under contract RGHRP in collaboration with BLM San Luis Valley Field Office.

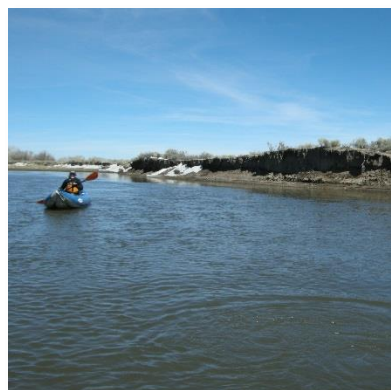
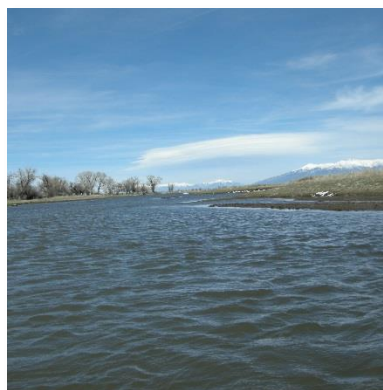
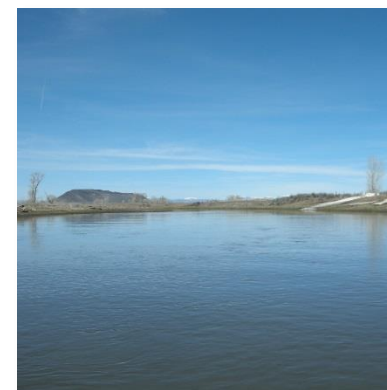
Mileage (Bottom Station)	Condition Notes	High Priority/ Easy Access 5 4 3 2 1 Low Priority
MILE 11-12 (633+60)	The study team floated the west channel and observed a low bench on river right; serious lack of riparian vegetation; rip rap on river right; livestock observed and upslope over grazing appears to be causing erosion.	2 Still entirely within private property, mile 11-12 would require land owner permissions, and likely creation of access point(s). With interest from stakeholders, the river would benefit from channel shaping, bank stabilization and fishery improvements. Riparian rehabilitation and an evaluation land management practices would also be useful to restore the health of the river. Potential for wetland habitat creation utilizing irrigation return water.
MILE 12-13 (686+40)	East channel re-joins at ~658+00 Wide floodplain and alternating high banks on both sides of the river	3 Entirely within private property, mile 12-13 would require access from the downstream limit where BLM property begins on river right. With interest from stakeholders, the river would benefit from channel shaping, bank stabilization and fishery improvements. Potential for wetland habitat creation utilizing irrigation return water.

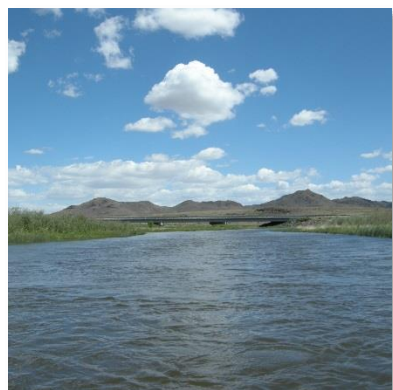
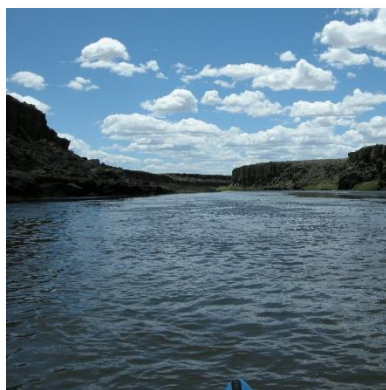
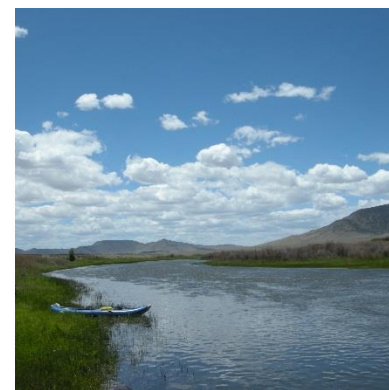
MILE 15-16 844+80	Little to no riparian vegetation, canyon incises some on river right as well. Floodplain within incision is overwide—channel migration and aggradation is evident with bars.	
MILE 16-17 897+60	Several deep gullies confluence on river right, leaving noted depositions which constrict the river. Horses observed near channel split (and overwide floodplain/ water crossing) from ~885+00-893+00.

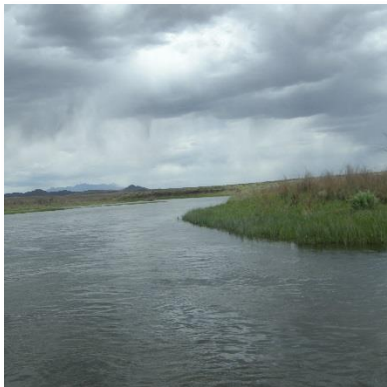
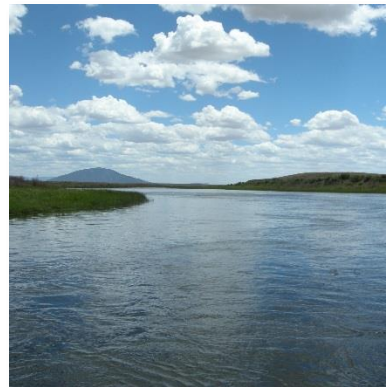
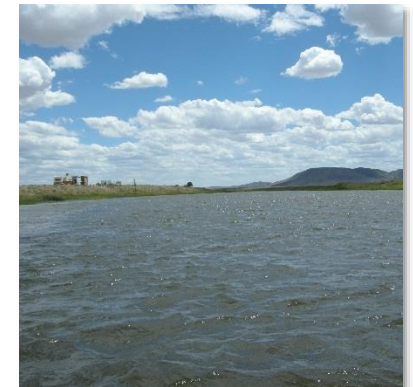
MILE 24-25 (1320+40)	Canyon incision remains but floodplain within varies; some older cottonwoods observed, but minimal riparian vegetation throughout.	
REACH #4 ENDS AT THE G ROAD/ LOBATOS BRIDGE ~ 1352+00

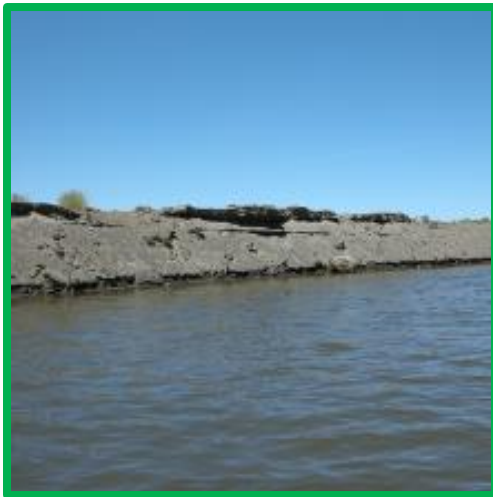
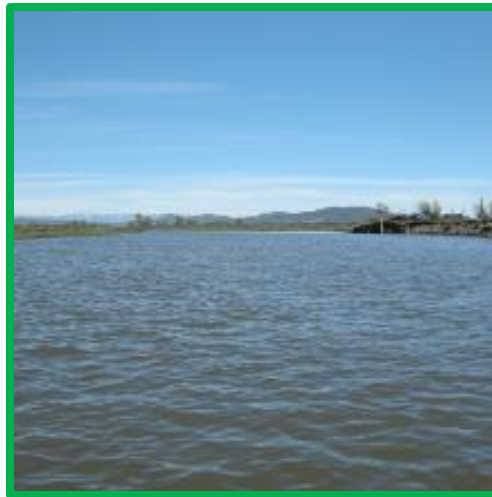
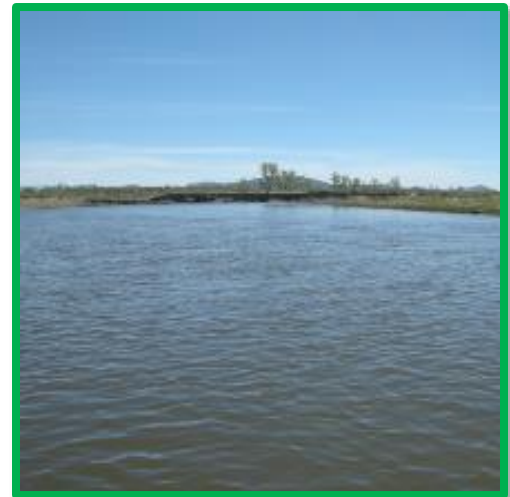
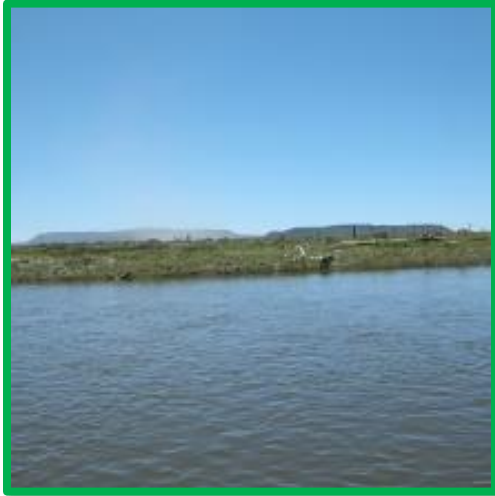
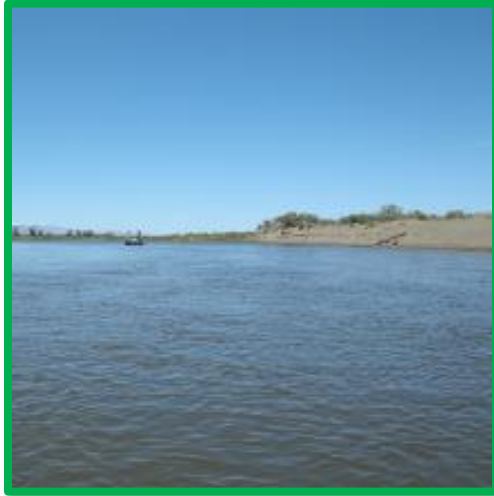
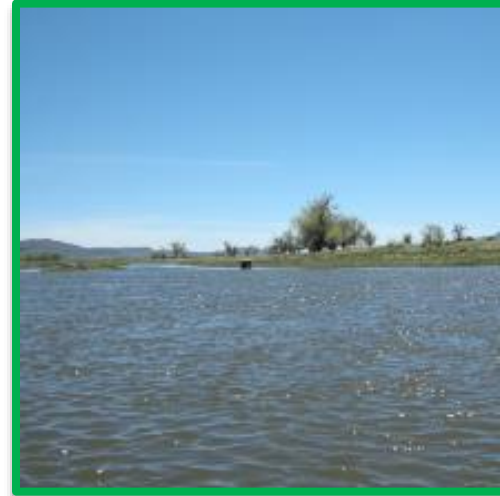
ABOVE: PP #4 (Station 85+00) Downstream | PP #4 (Station 85+00) Upstream | PP #5 (Station 116+00) Downstream
 BELOW: PP #5 (Station 116+00) Left Bank | PP #5 (116+00) Upstream | BOTTOM: PP #6 (130+00) Downstream
 NOTE: Cut Banks on both sides. Station 85+00 shows evidence of overgrazing upstream. Minimal riparian vegetation.

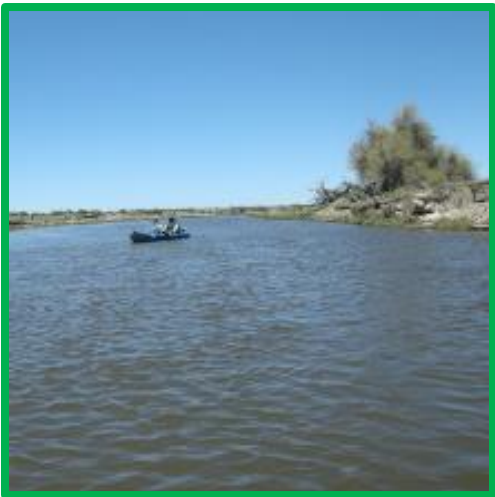
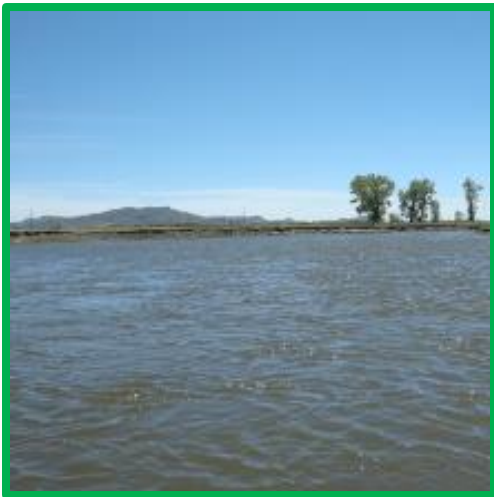
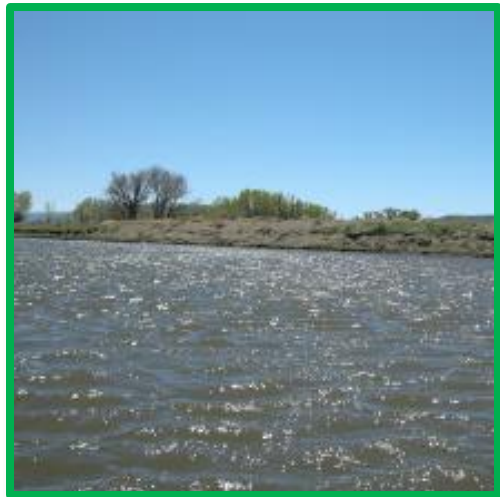
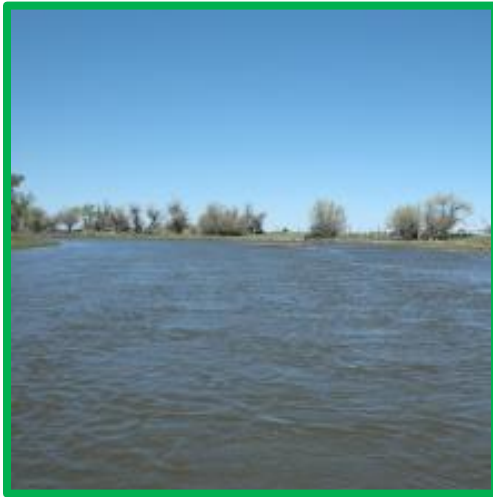
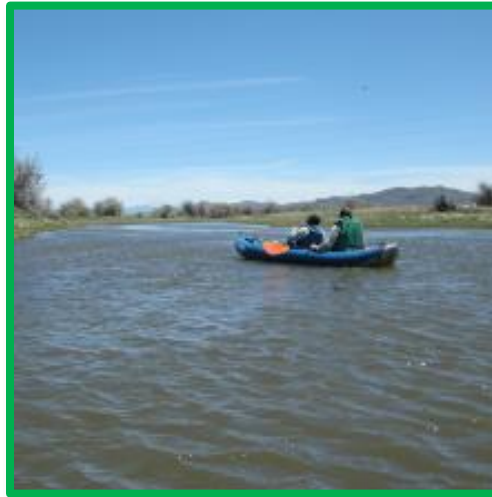
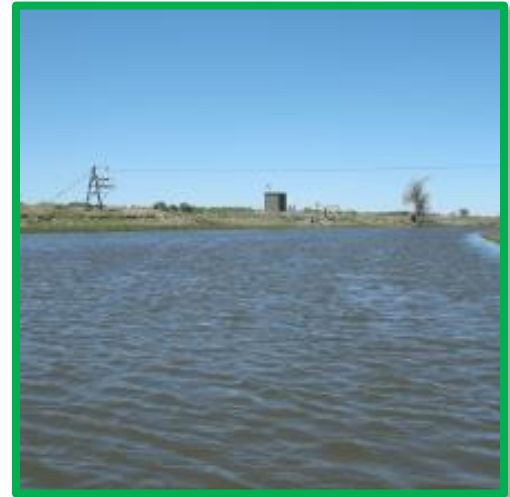
ABOVE: PP #6 (Station 130+00) Right Bank | PP #6 (Station 130+00) Upstream | PP #7 (Station 155+00) Downstream
 BELOW: PP #7 (Station 155+00) Upstream | PP #8 (Station 195+00) Downstream | PP #8 (Station 195+00) Right Bank
 NOTE: Elk and Carp observed. Cut banks in places, and wide grassy sloped banks in others.

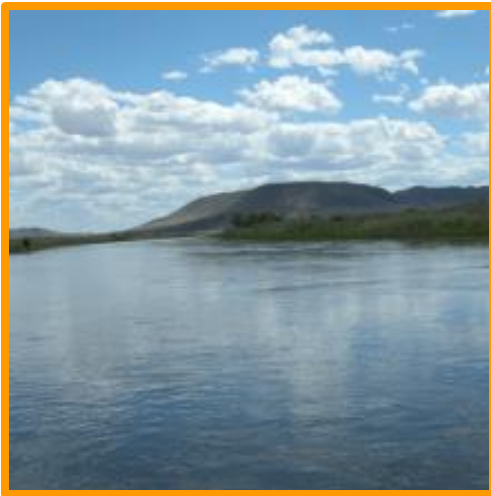
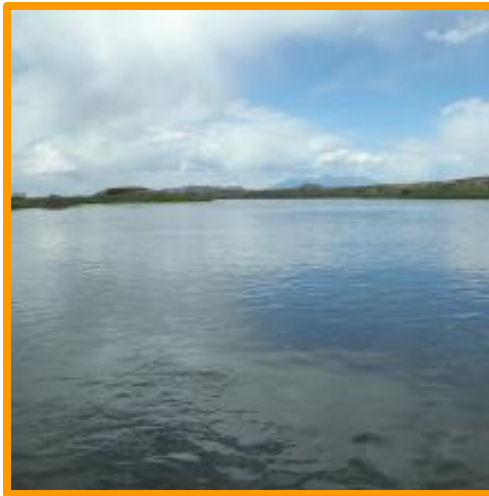
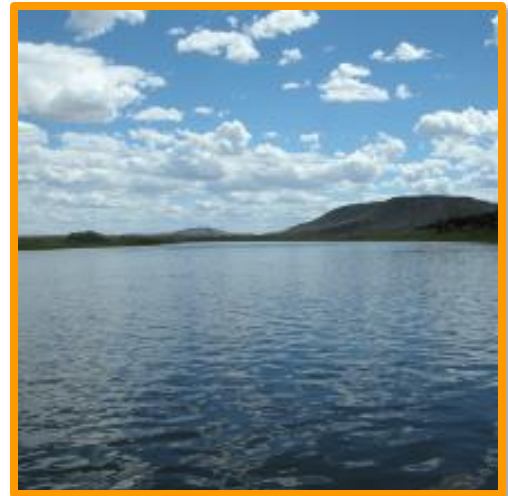
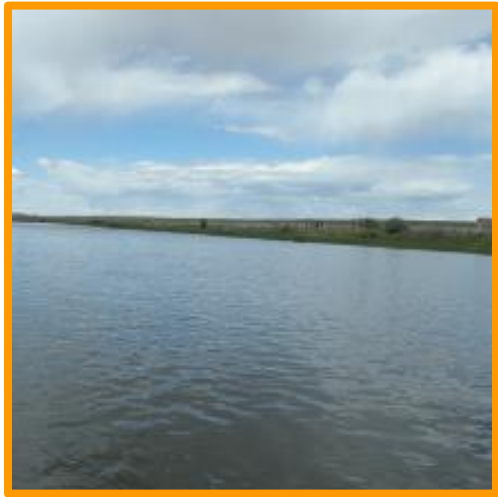
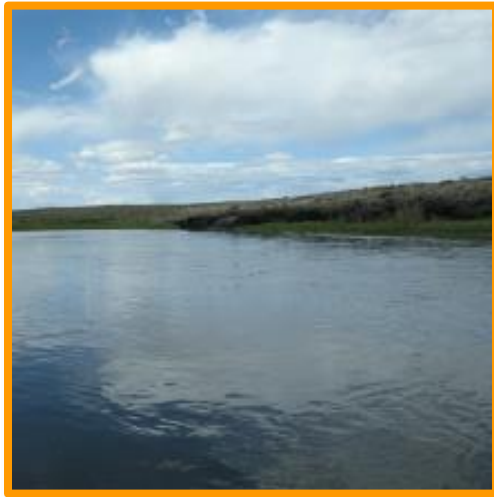
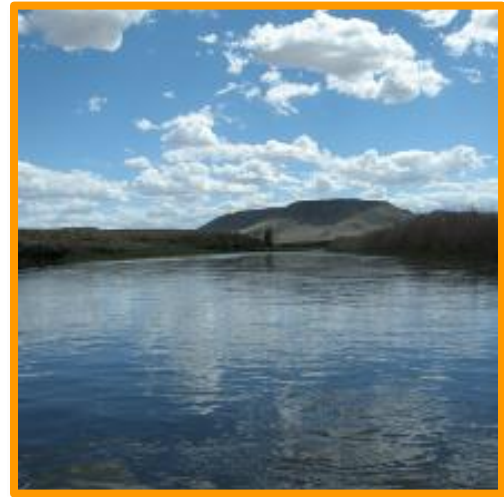
TOP: PP #42 (Station 1161+00) Upstream | PP #43 (Station 1215+00) Downstream | PP #43 (Station 1215+00) Upstream
 BOTTOM: PP #44 (Station 1268+00) Downstream | PP #44 (Station 1268+00) Upstream | P #45 (Station 1287+00) Downstream
 NOTE: Horses observed on river left. Small grove of old growth cottonwoods on river right.
