RIO GRANDE NATURAL AREA RIVER CONDITION ASSESSMENT APRIL 2016 REPORT

The report was prepared by Riverbend Engineering, LLC under contract RGHRP in collaboration with BLM San Luis Valley Field Office.

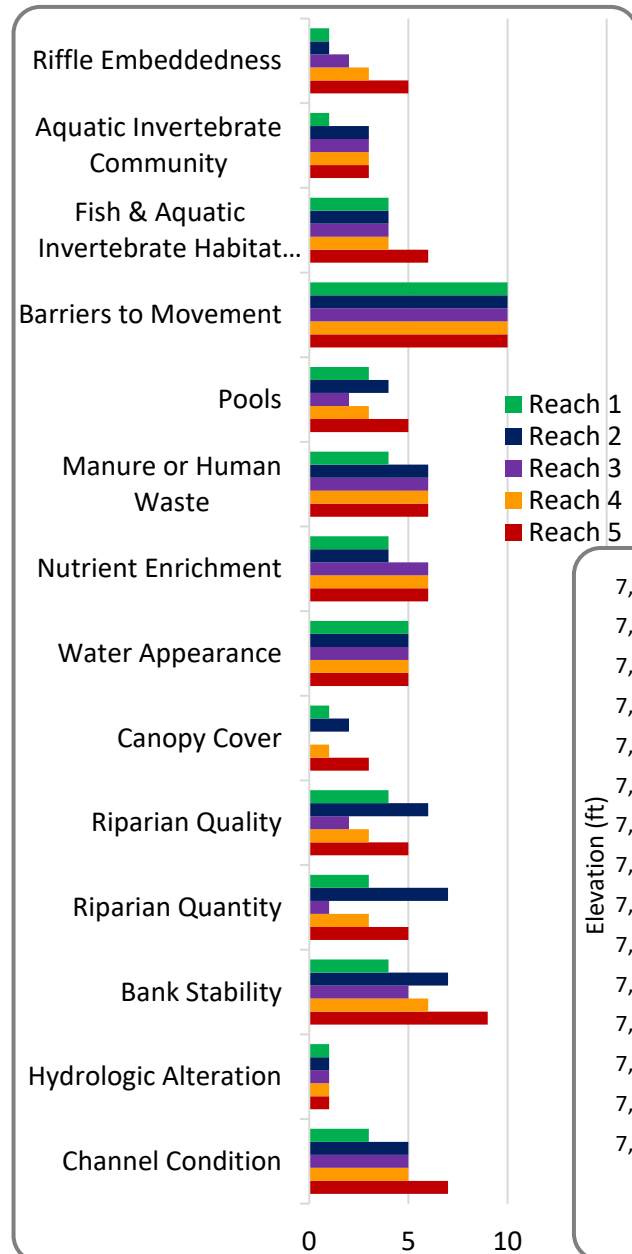
STREAM VISUAL ASSESSMENT

Colorado NRCS considers a score of 5 or less to indicate poor or severely degraded conditions. For this study SVAP scores were not utilized to determine priority project areas, but do provide a broad view of the health of the river.

These scores show two trends that are worthy of noting: (1) The upper reaches had consistently lower scores than the lower reaches, and (2) many reaches of the river show poor habitat conditions such as a lack of canopy cover, riffles, and pools.

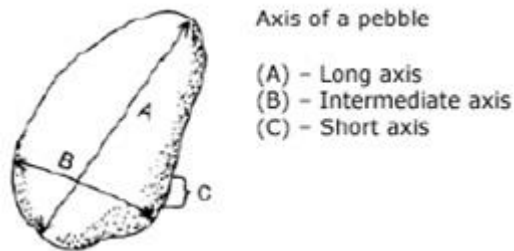
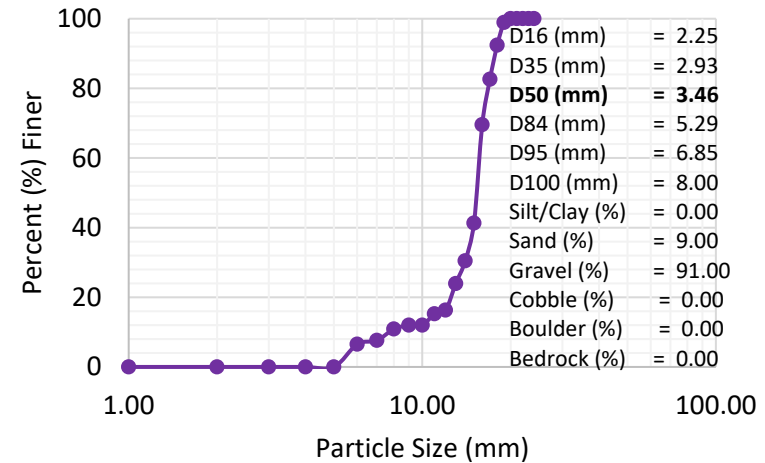
**Hwy 142 Bridge Pebble Count
Sta 940+00**

The HWY 142 Bridge is in Reach #3 and the average sediment size (intermediate axis, see below) was ~3.46 mm; and at the G Road Bridge in Reach #5 it was ~14.62 mm. Reach #5 has a higher slope, supporting larger cobble and is not aggrading like the upper reaches where finer sediments were found. While informative, this data does not draw any definitive conclusions except to contribute to the stream-type calculations derived for each reach.

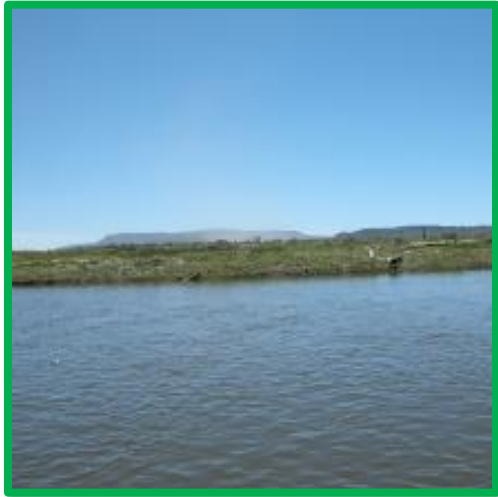
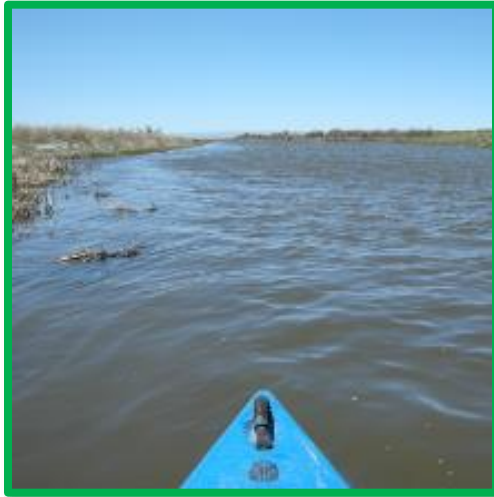
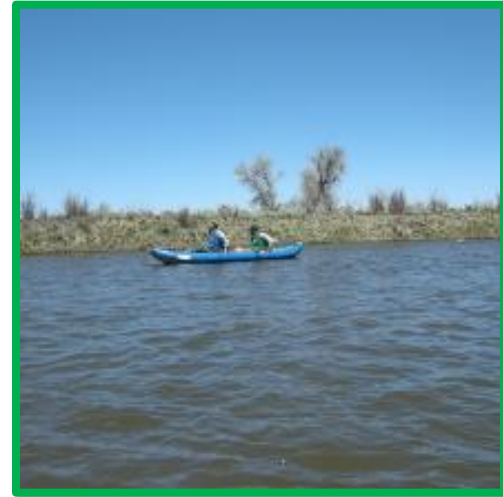
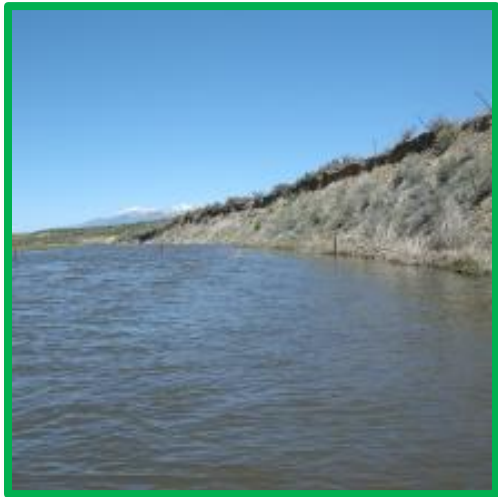
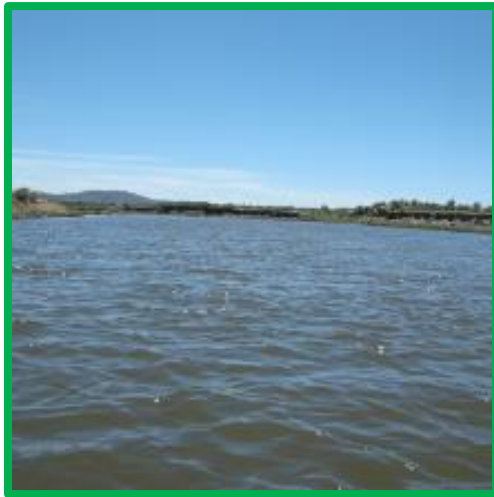
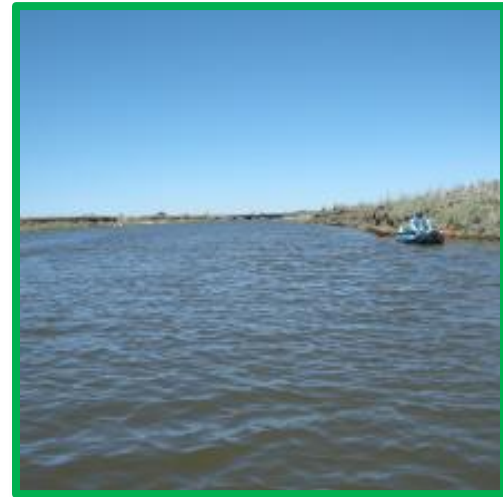
ABOVE: PP #1 (Station 25+00) Downstream | PP #2 (Station 51+00) Downstream | PP #2 (Station 51+00) Right Bank
BELOW: PP #2 (Station 51+00) Upstream | PP #3 (Station 74+00) Downstream | PP #3 (Station 74+00) Upstream
NOTE: Vertical cut banks, channel bars, sparse large riparian vegetation. Water visibility ~1-1½ feet on 20 May 2014.

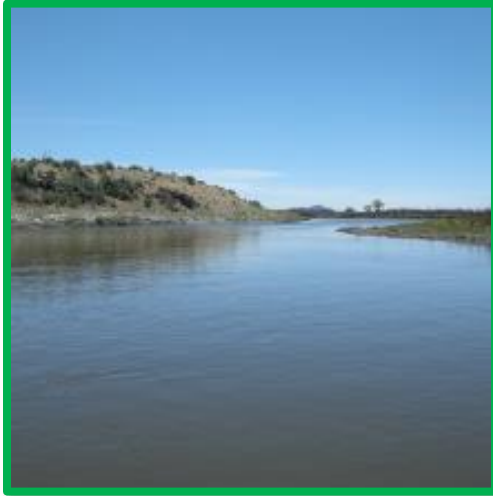
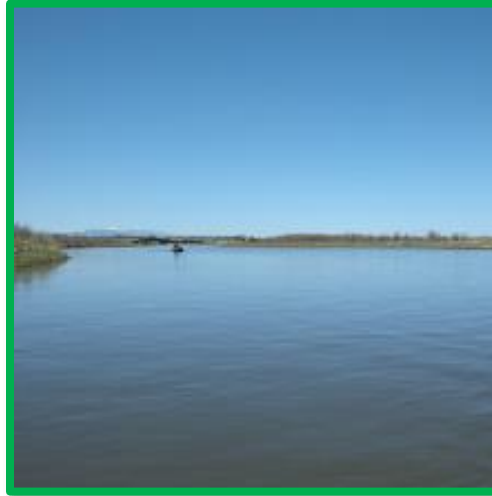
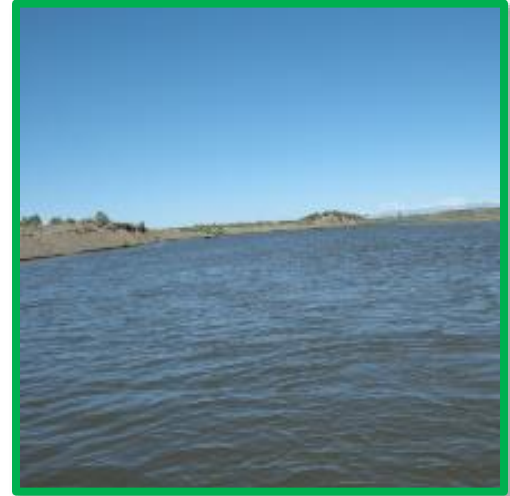
ABOVE: PP #4 (Station 85+00) Downstream | PP #4 (Station 85+00) Upstream | PP #5 (Station 116+00) Downstream
 BELOW: PP #5 (Station 116+00) Left Bank | PP #5 (116+00) Upstream | BOTTOM: PP #6 (130+00) Downstream
 NOTE: Cut Banks on both sides. Station 85+00 shows evidence of overgrazing upstream. Minimal riparian vegetation.

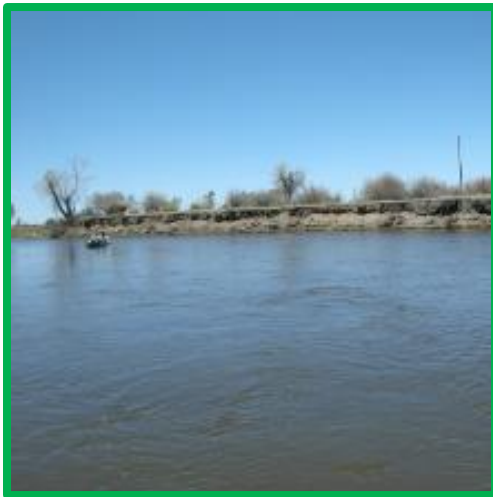
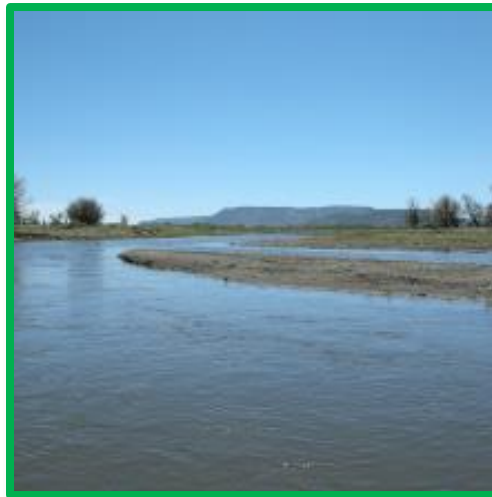
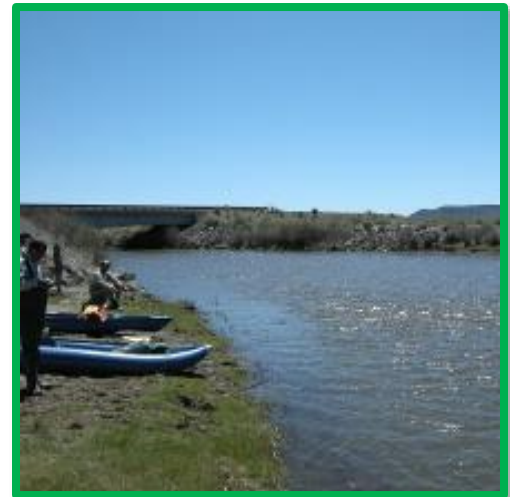
ABOVE: PP #8 (Station 195+00) Upstream | PP #9 (Station 218+00) Downstream | PP #9 (Station 218+00) Upstream
 BELOW: PP #10 (Station 236+00) Downstream | PP #10 (Station 236+00) Upstream | PP #11 (Station 259+00) Downstream
 Note: Vertical cut banks and overgrazing. Top right photo shows USGS gauge. Bottom right photo shows the Z Rd Bridge.

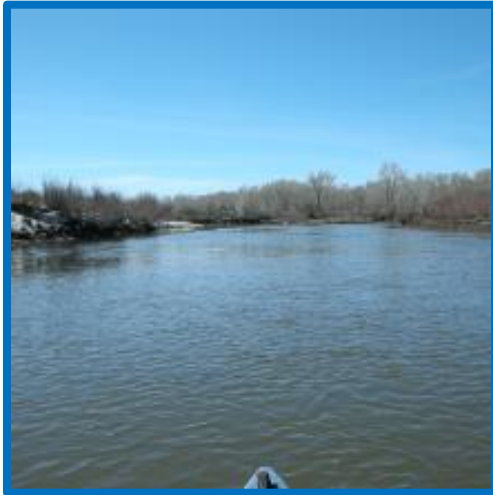
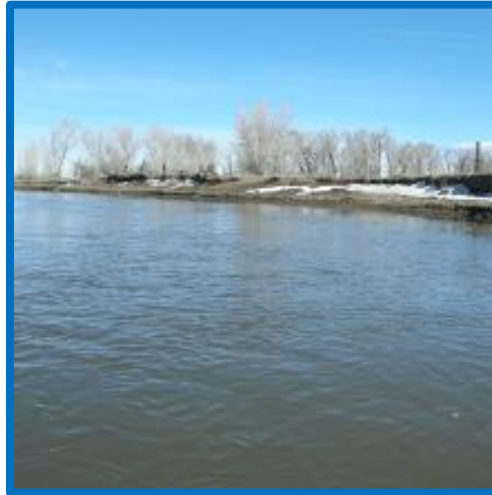
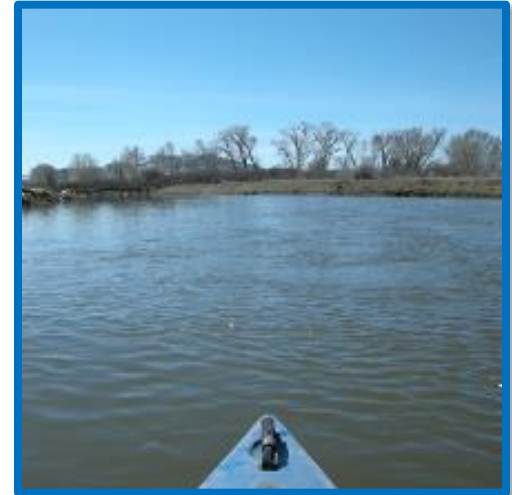
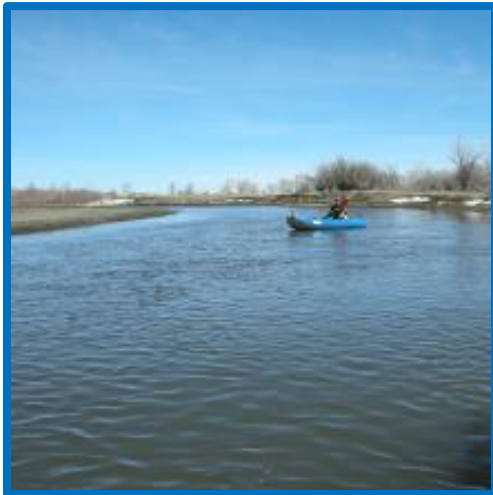
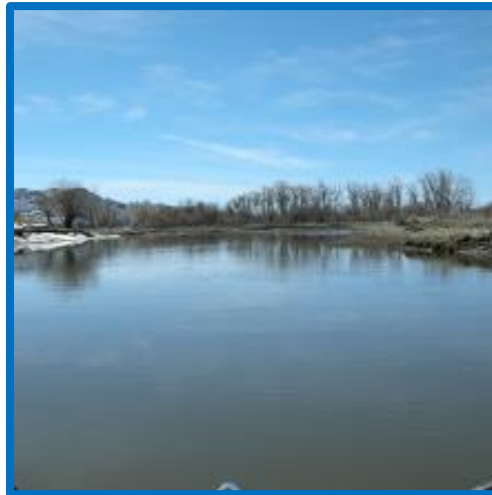
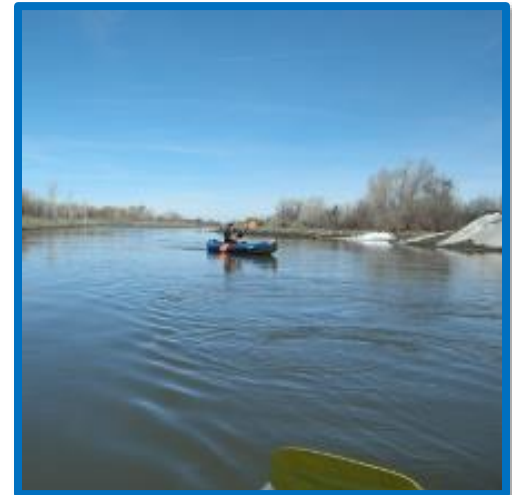
ABOVE: PP #12 (Station 272+00) Downstream | PP #12 (Station 272+00) Upstream | PP #13 (Station 280+00) Downstream

BELOW: PP #13 (Station 280+00) Upstream | PP #14 (Station 327+00) Downstream | PP #14 (Station (327+00) Upstream

NOTE: Top right photo looks toward Rio Conejos confluence. Healthy woody riparian vegetation.

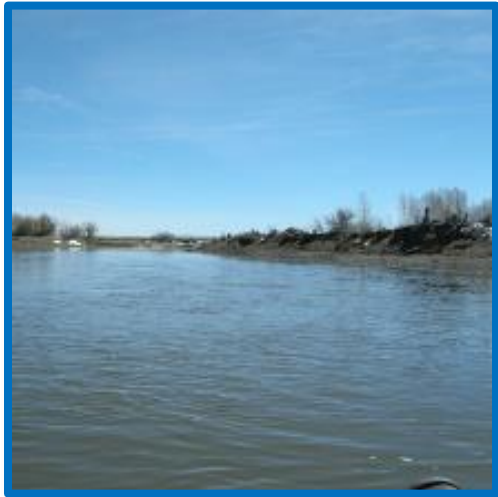
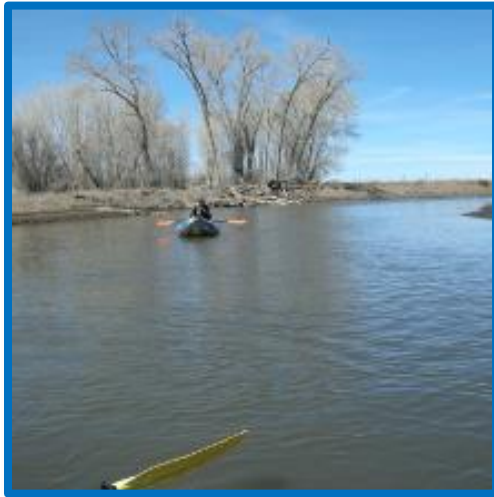
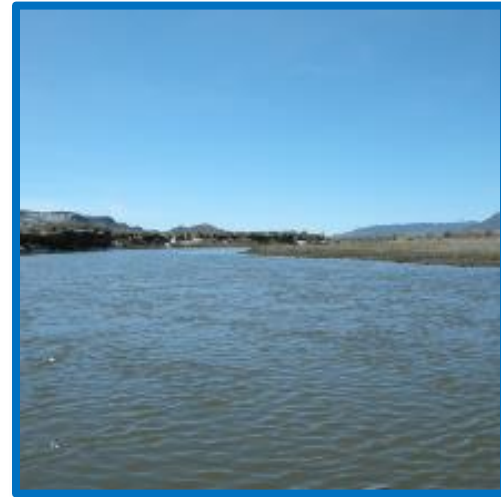
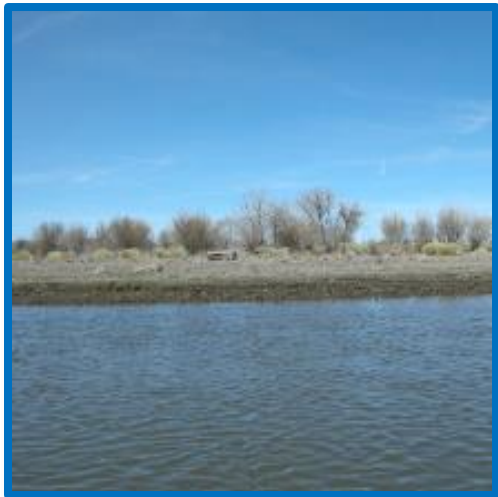
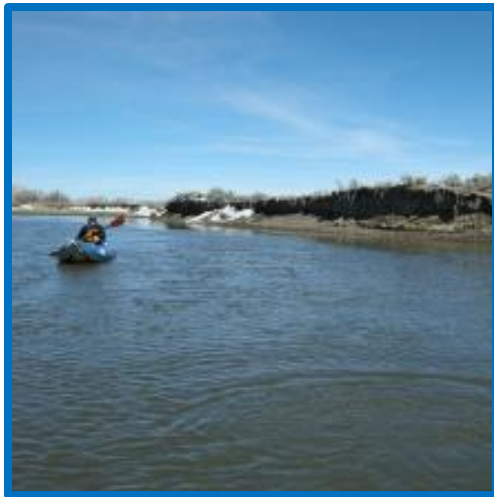
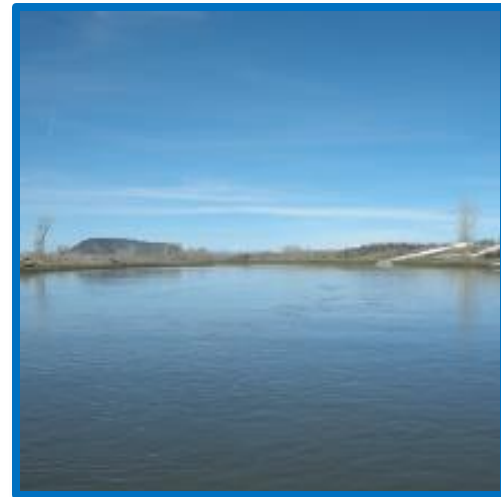
ABOVE: PP #15 (Station 355+00) Downstream | PP #15 (Station 355+00) Upstream | PP #16 (Station 387+00) Downstream

BELOW: PP #16 (Station 387+00) Left Bank | PP #16 (Station 387+00) | PP #17 (Station 418+00) Downstream

NOTE: Vertical Cut banks

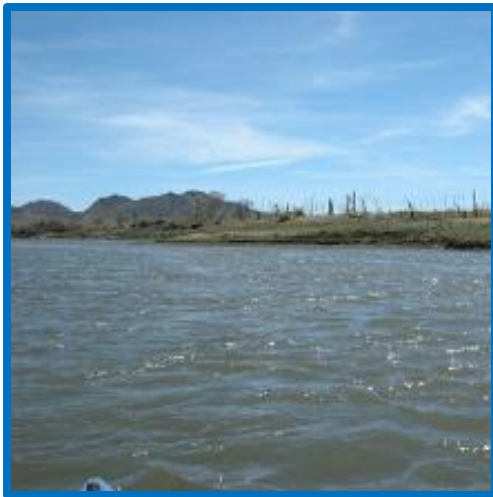
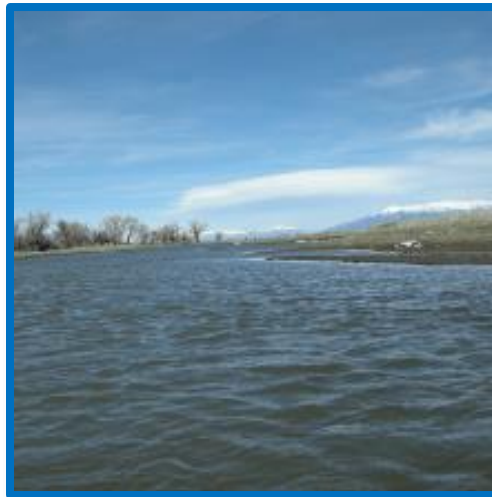
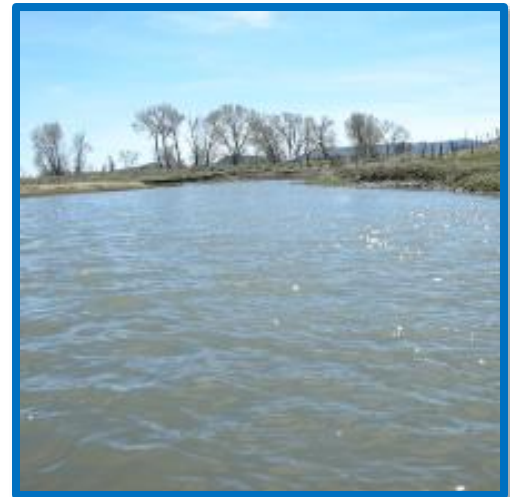
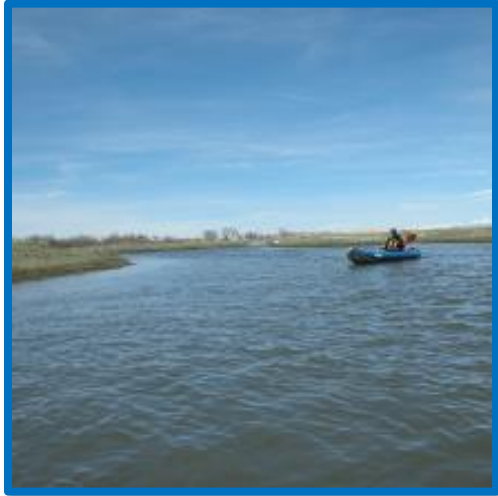
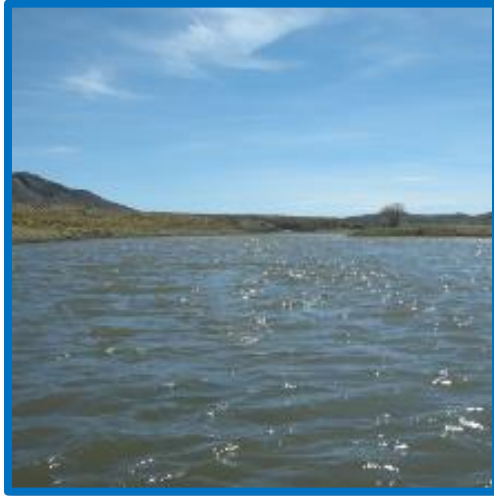
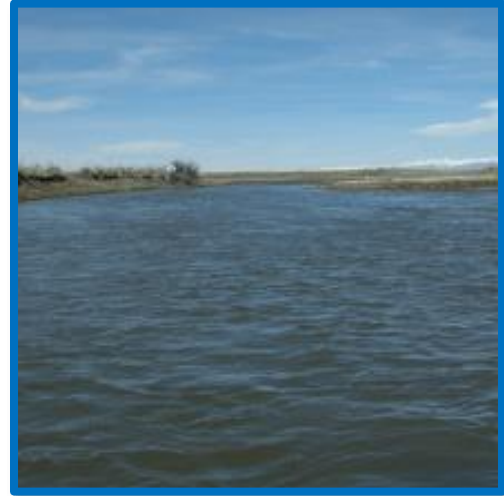
TOP: PP #25 (Station 631+00) Upstream | PP #26 (Station 650+00) Downstream | PP #26 (Station 650+00) Upstream
 BOTTOM: PP #27 (Station 670+00) Downstream | PP #27 (Station 670+00) Upstream | PP #28 (Station 720+00) Downstream
 NOTE: Canyon incision transition

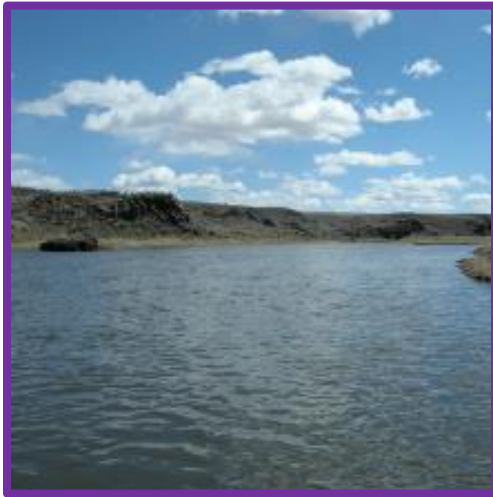
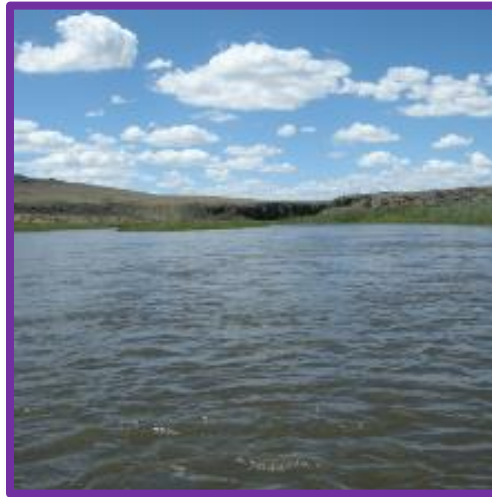
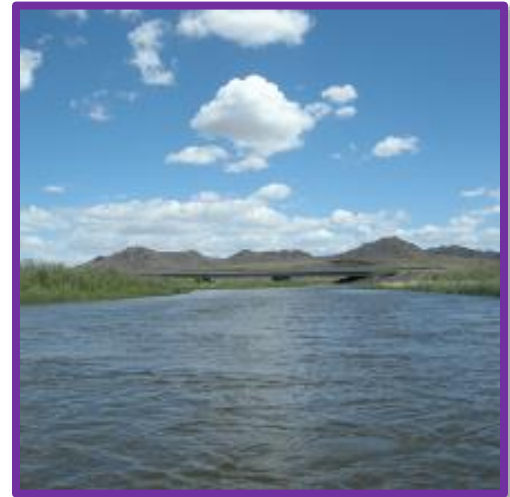
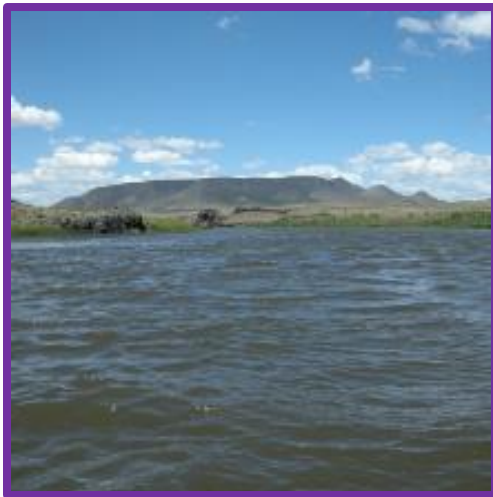
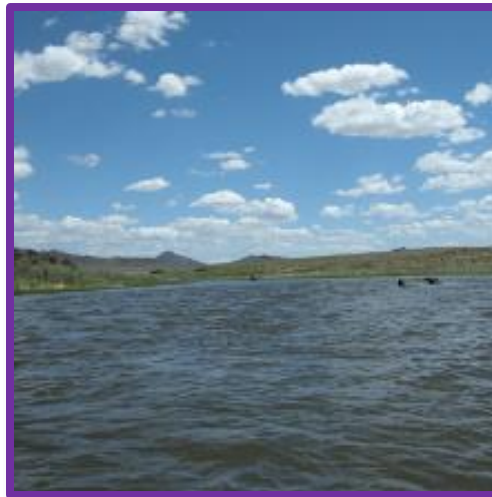
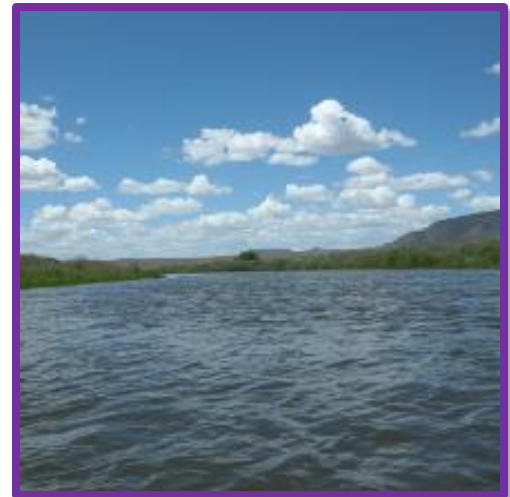
TOP: PP #32 (Station 880+00) Downstream | PP #33 (Station 925+00) Downstream | PP #33 (Station 925+00) Upstream
 BOTTOM: PP #34 (Station 945+00) Downstream | PP #34 (Station 945+00) Upstream | PP #35 (Station 955+00) Downstream
 NOTE: Transition out of canyon incision

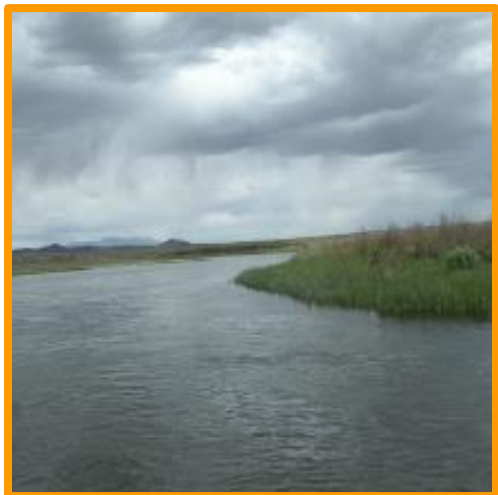
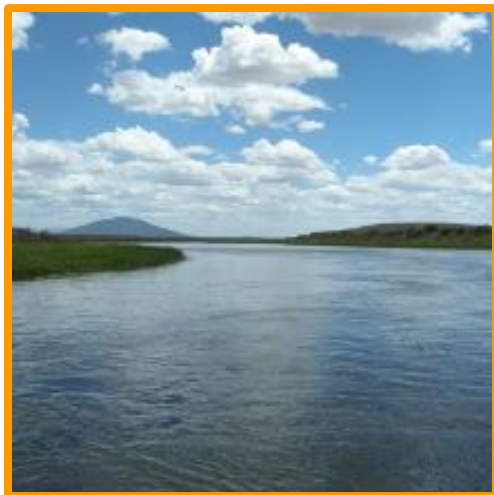
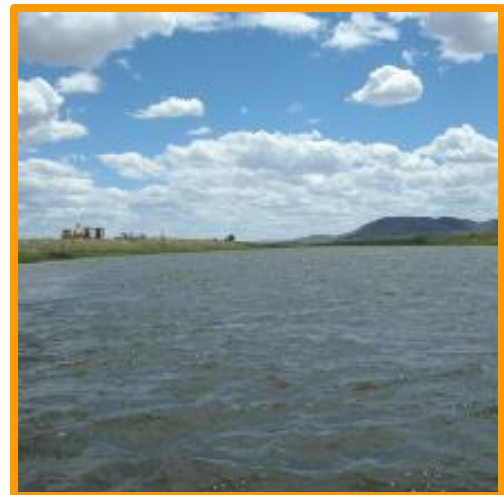
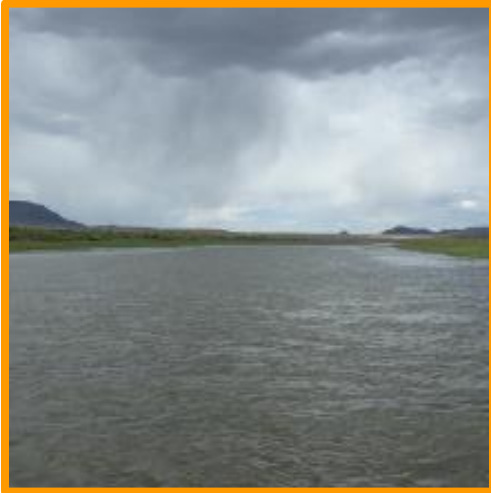
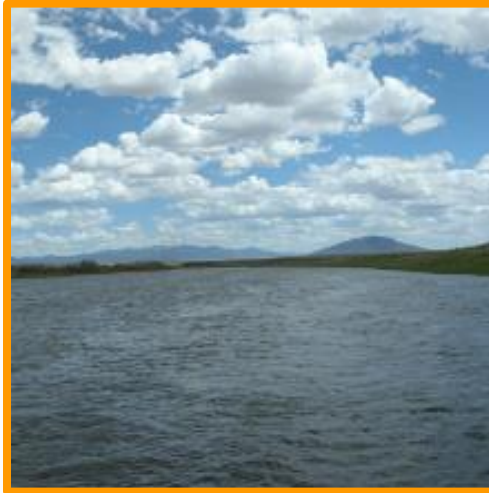
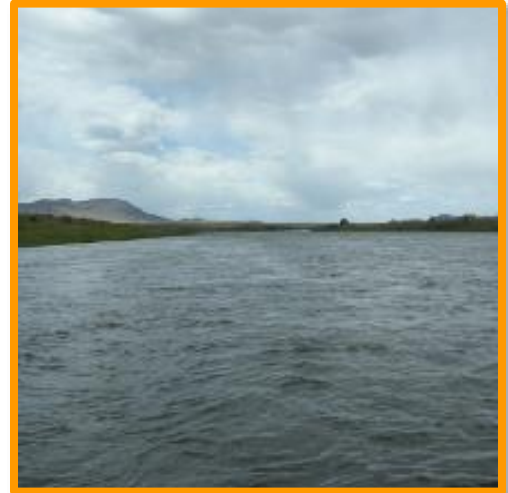
TOP: PP #42 (Station 1161+00) Upstream | PP #43 (Station 1215+00) Downstream | PP #43 (Station 1215+00) Upstream
 BOTTOM: PP #44 (Station 1268+00) Downstream | PP #44 (Station 1268+00) Upstream | P #45 (Station 1287+00) Downstream
 NOTE: Horses observed on river left. Small grove of old growth cottonwoods on river right.

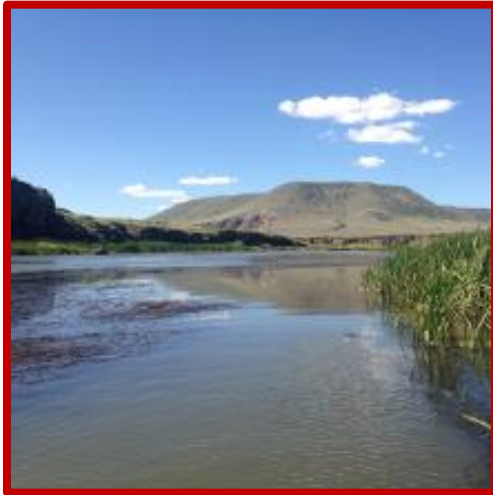
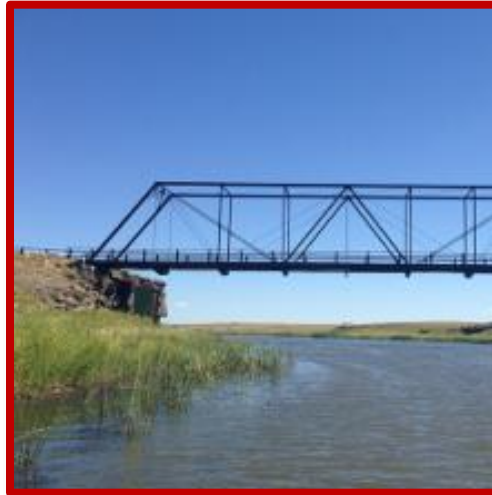
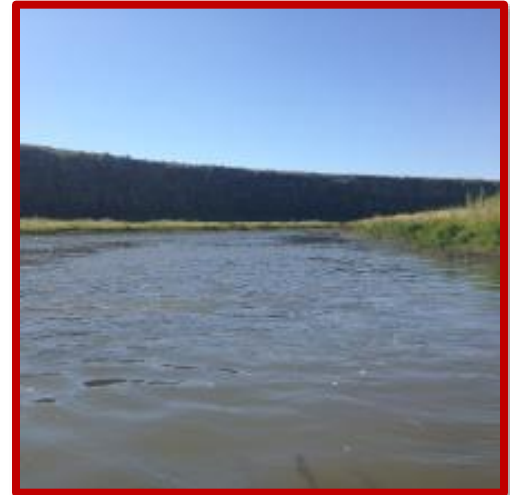
TOP: PP #48 (Station 1390+00) Downstream | PP #48 (Station 1390+00) Upstream | PP #49 (Station 1412+00) Downstream
BOTTOM: PP #49 (Station 1412+00) Upstream | PP #50 (Station 1425+00) Downstream | PP #50 (Station 1425+00) Upstream
NOTE: Top of reach is G. Road Bridge. Enters incised canyon with limited floodplain.

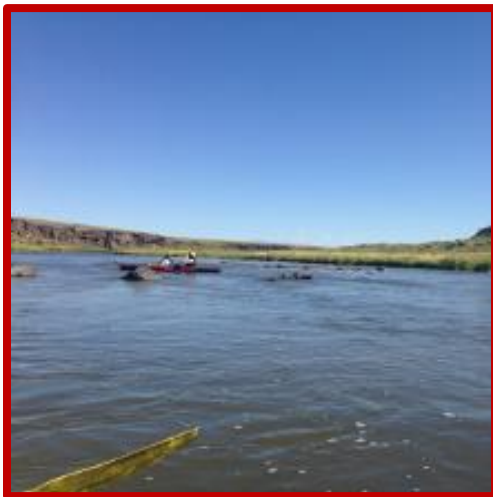
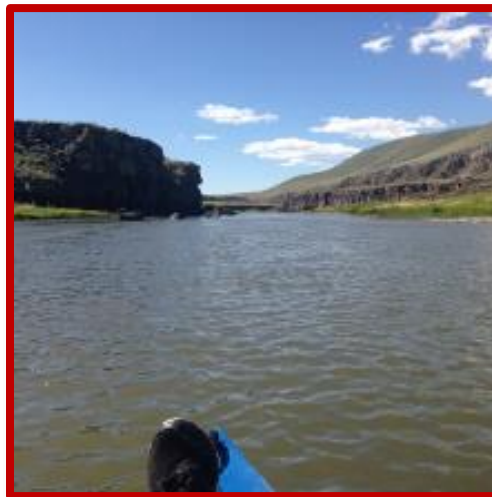
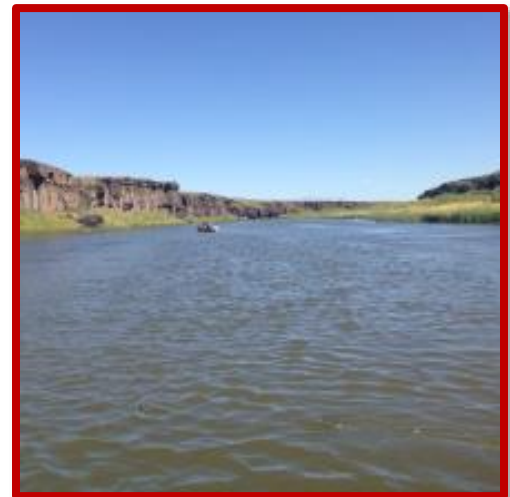
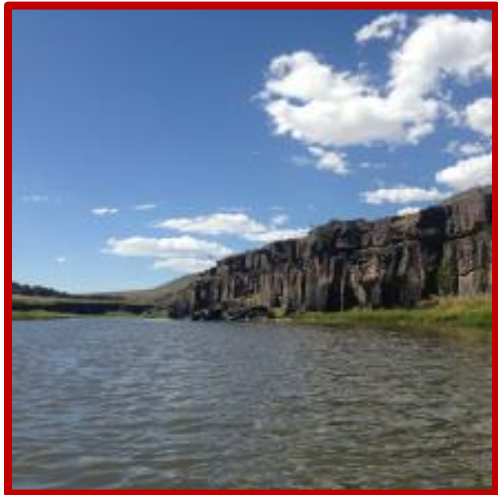
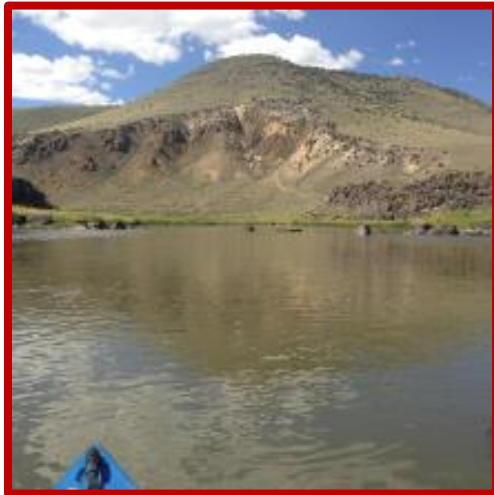
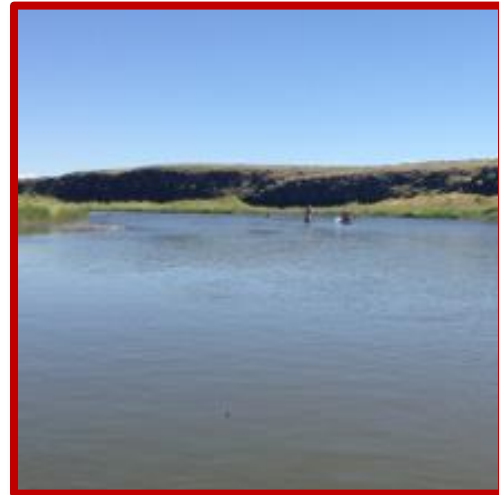
TOP: PP # 51 (Station 1448+00) Downstream | PP #52 (Station 1453+00) Downstream | PP #52 (Station 1453+00) Upstream
 BOTTOM: PP #53 (Station 1470+00) Downstream | PP #53 (Station 1470+00) Upstream | PP #54 (station 1482+00) Downstream
 NOTE: Width of canyon incision and intermittent floodplain changes, but river is bound geologically through much of Reach #5.

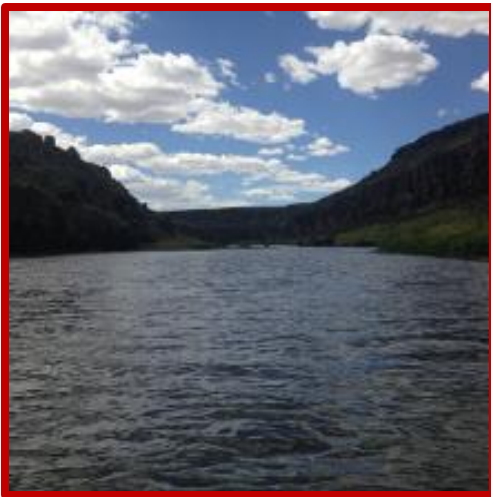
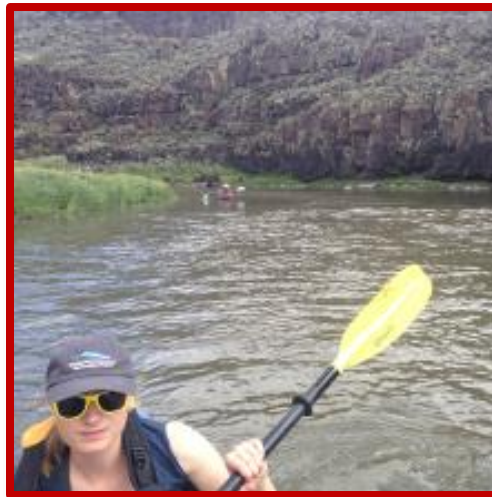
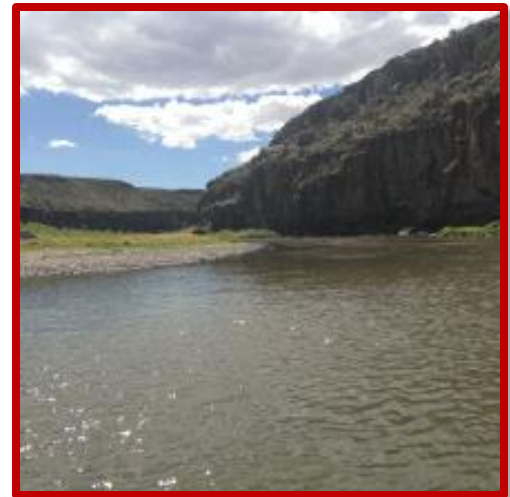
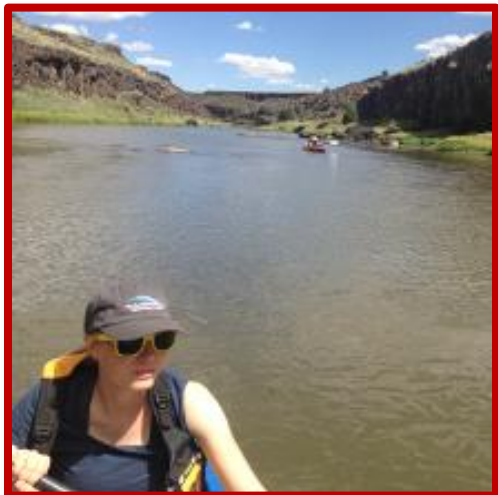
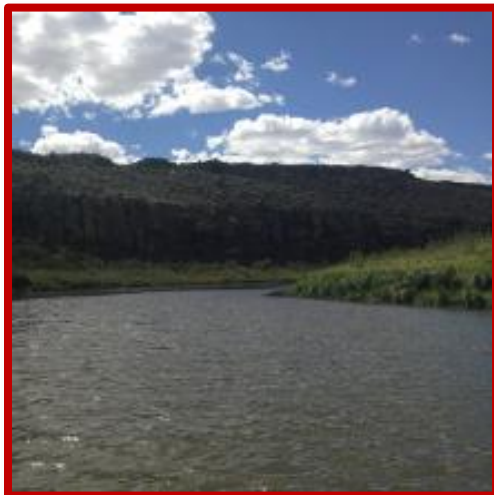
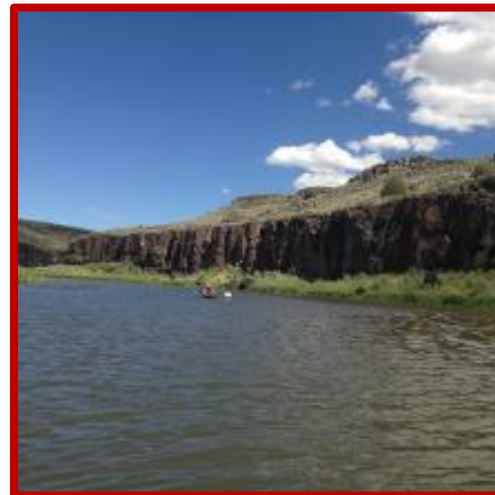
TOP: PP #57 (Station 1515+00) Upstream | PP #58 (Station 1535+00) Downstream | PP #58 Station 1535+00 Upstream

BOTTOM: PP #59 (Station 1548+00) Downstream | PP #59 (Station 1548+00) Upstream | PP #60 (Station 1561+00) Downstream

NOTE: This section of this reach represents the largest drop in slope in the study area—the boats are beached after an unexpected swim.

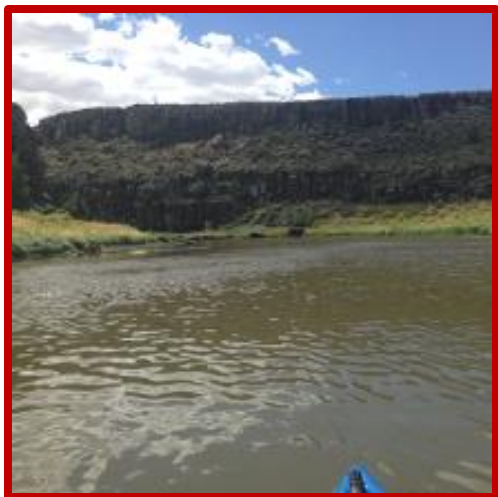
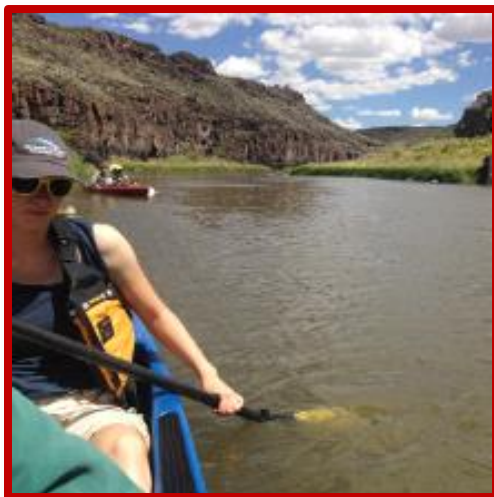
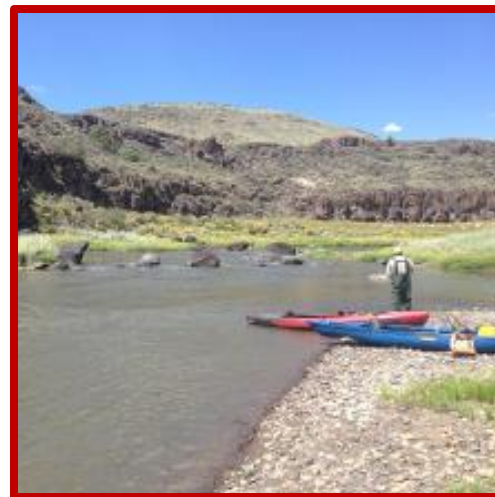
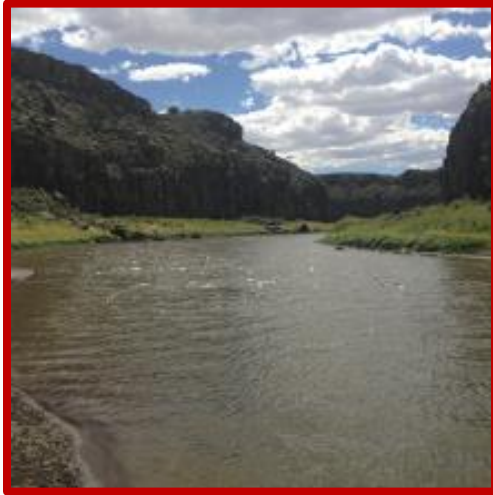
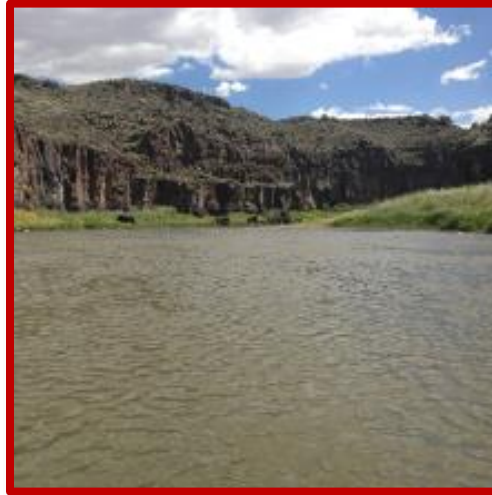
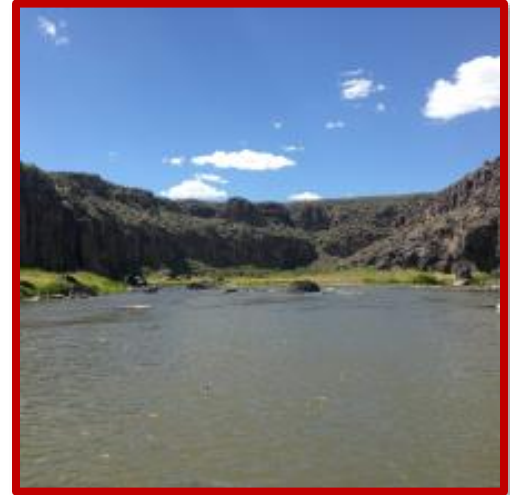
TOP: PP #60 (Station 1561+00) Upstream | PP #61 (Station 1578+00) Downstream | PP #61 (Station 1578+00) Upstream

BOTTOM: PP #62 Downstream | PP #62 Upstream | PP #63 Downstream

NOTE: Due to the above mentioned swim, data was lost with stationing for the photo points in the last 5 miles above the NM state line.

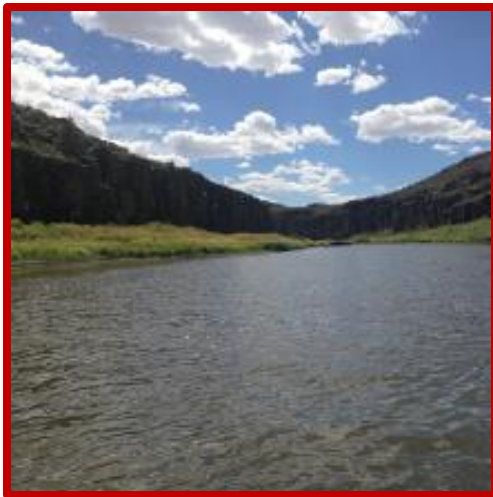
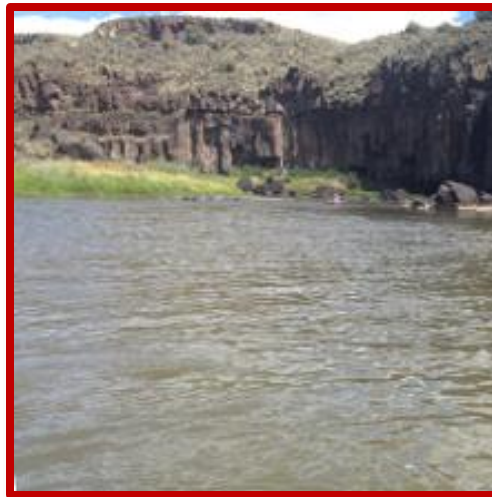
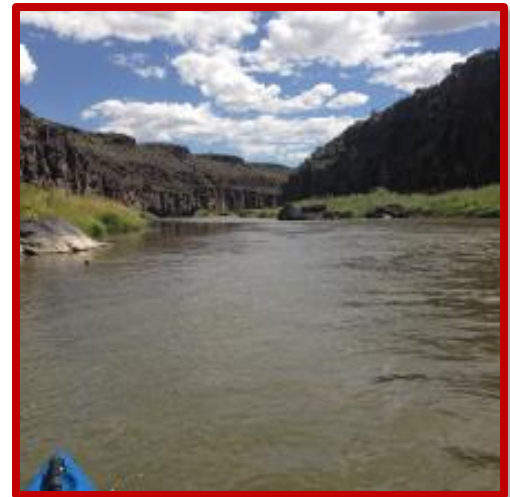
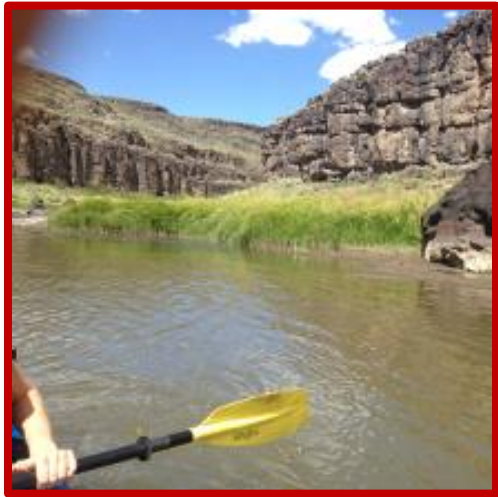
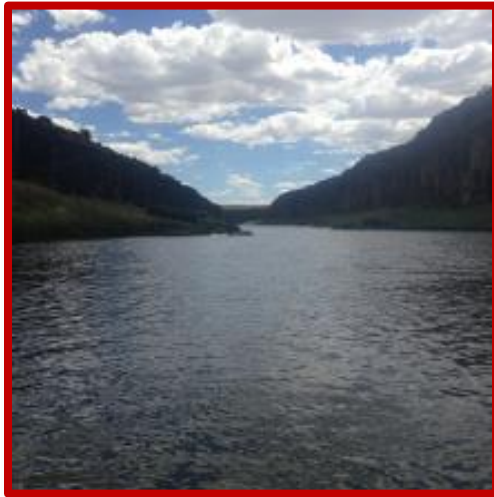
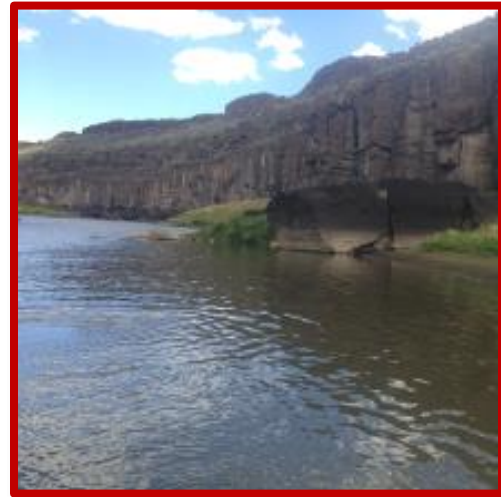
TOP: PP #63 Upstream | PP #64 Downstream | PP #64 Upstream

BOTTOM: PP #65 Downstream | PP #65 Upstream | PP #66 Downstream

NOTE: River remains well incised in the canyon with few access points up the cliffs. BLM on the right and private on the left.

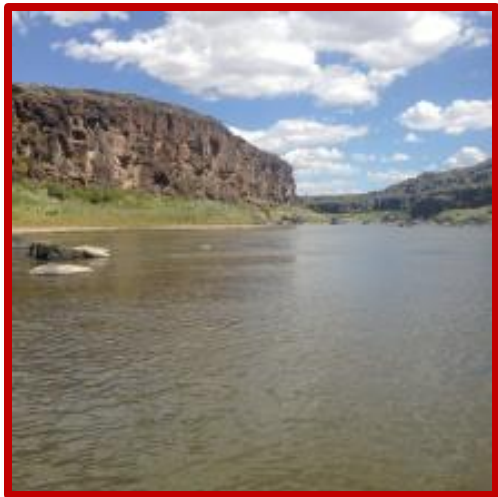
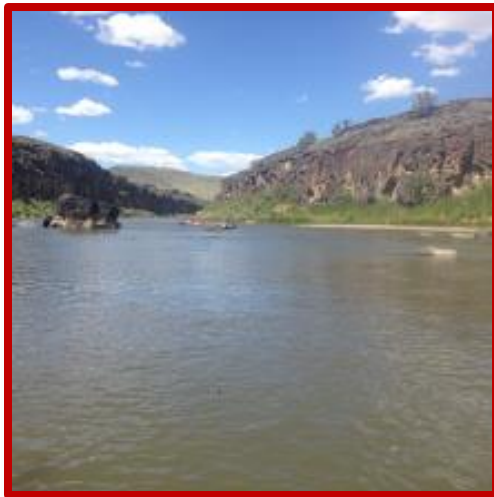
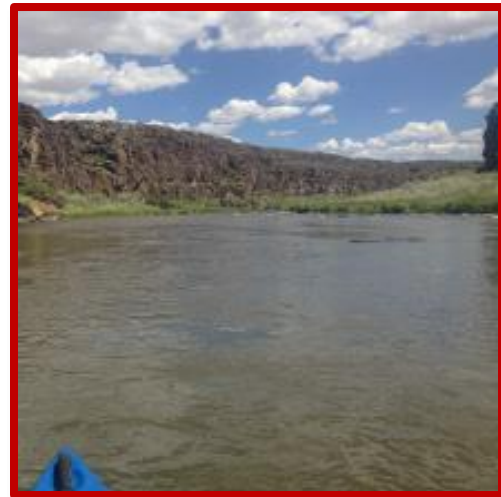
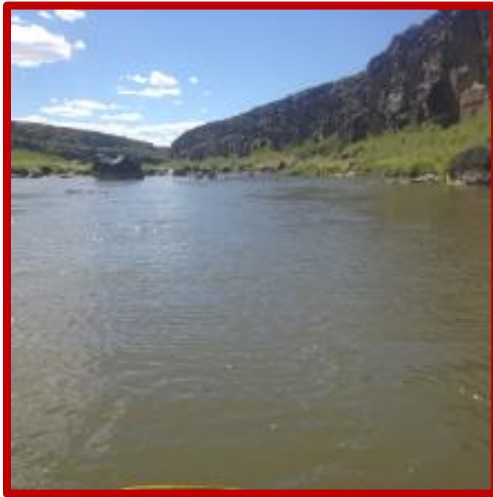
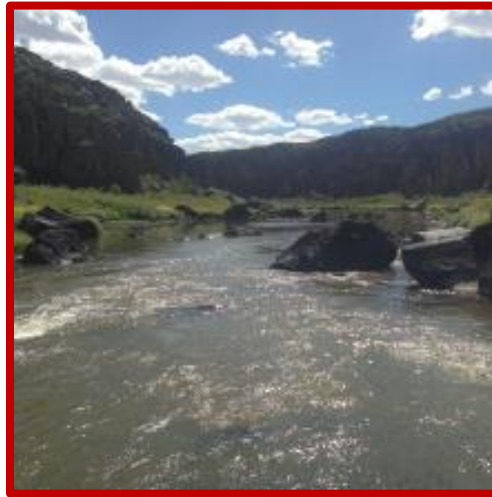
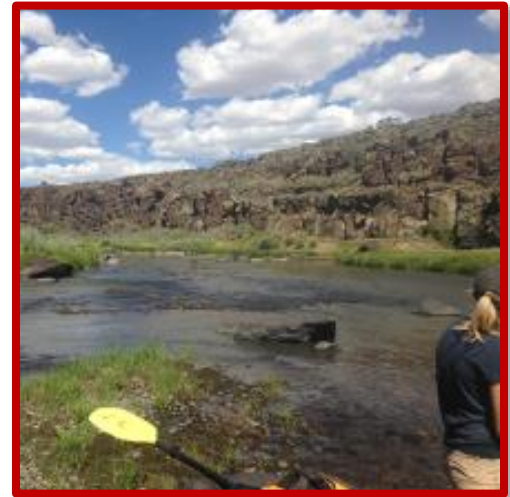
TOP: PP #66 Upstream | PP #67 Downstream | PP #67 Upstream
 BOTTOM: PP #68 Downstream | PP #68 Upstream | PP #69 Downstream
 NOTE: Incision persists.

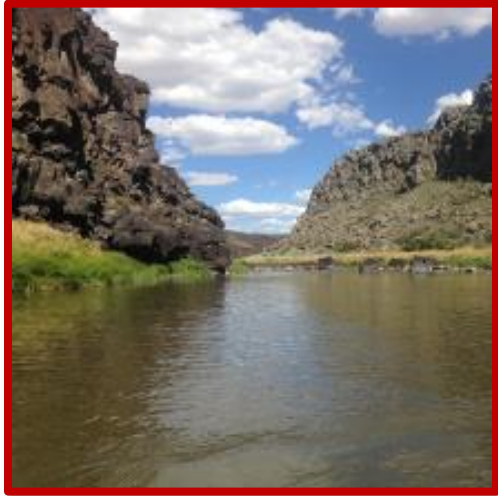
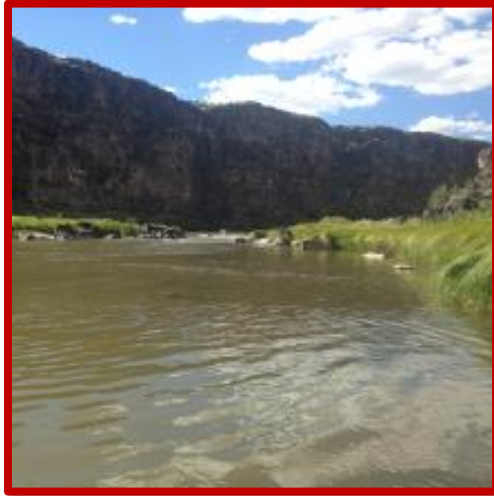
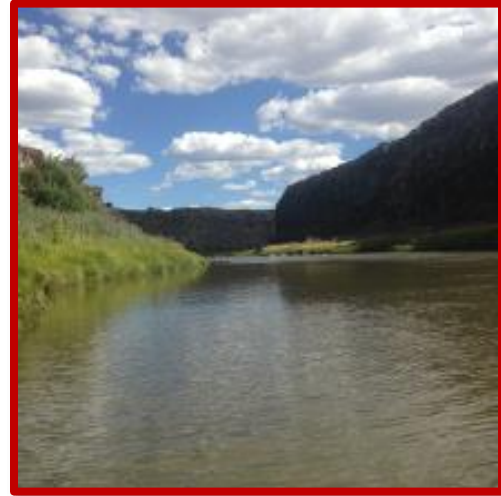
PHOTOS: PP #69 Upstream | PP #70 Downstream | PP #70 Upstream

NOTE: The Colorado/ New Mexico state line is unmarked. The study team exited on BLM property above the state line.
